## Legionnaires' Disease....are you minimizing the risk?

### Some steps you can take to minimize the risk of *Legionella* in your Building Water Systems.

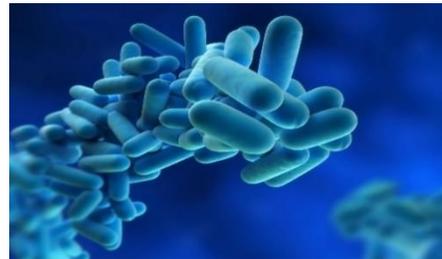
**Cooling Tower Water systems** continually receive potable make-up water to compensate for the water loss due to evaporation. If *Legionella* is present in the make-up water supply, then there is the potential for the cooling water system to promote an environment for *Legionella* growth and propagation due to warm water temperatures, stagnant water conditions, sediment, scale, deposits and nutrients from other microbiota such as algae and many bacteria.
